## Integrated geophysical investigation for pavement failure along a dual carriage way, Southwestern Nigeria: a case study

Akinola M. Adesola, Akinlalu A. Ayokunle\*, Adelusi O. Adebowale  
Dept. of Applied Geophysics, Federal University of Technology, Akure, Nigeria  
Corresponding author: aaakinlalu@futa.edu.ng

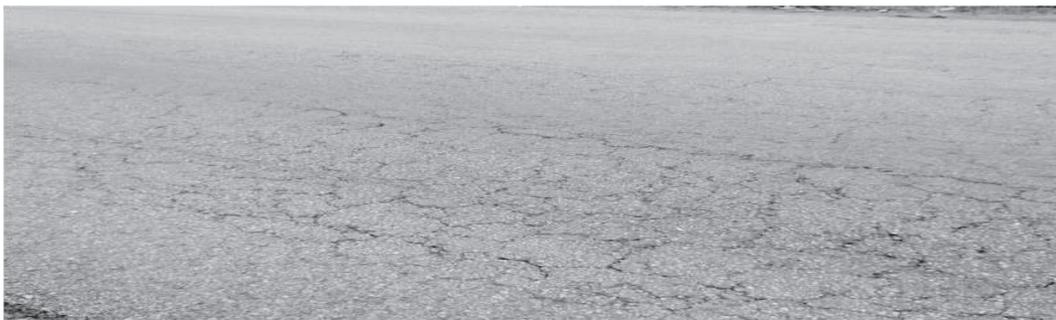
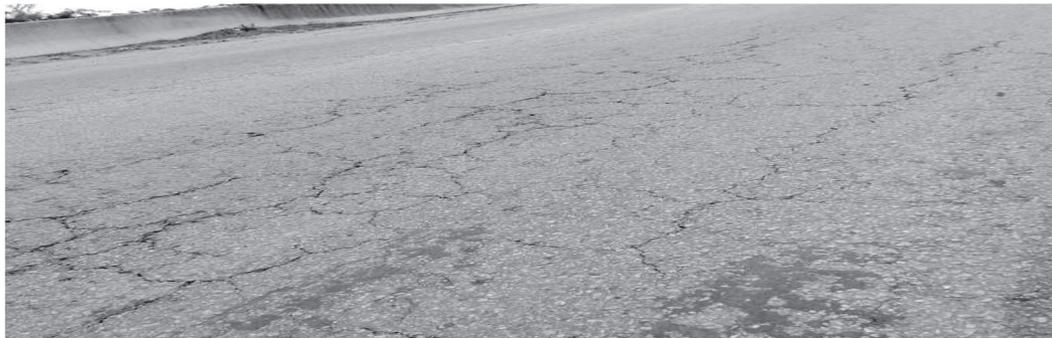
**PLATE 1**

**Fig. 2.** Typical Pavement Failure along Ogbomoso-Ilorin Highway, Nigeria

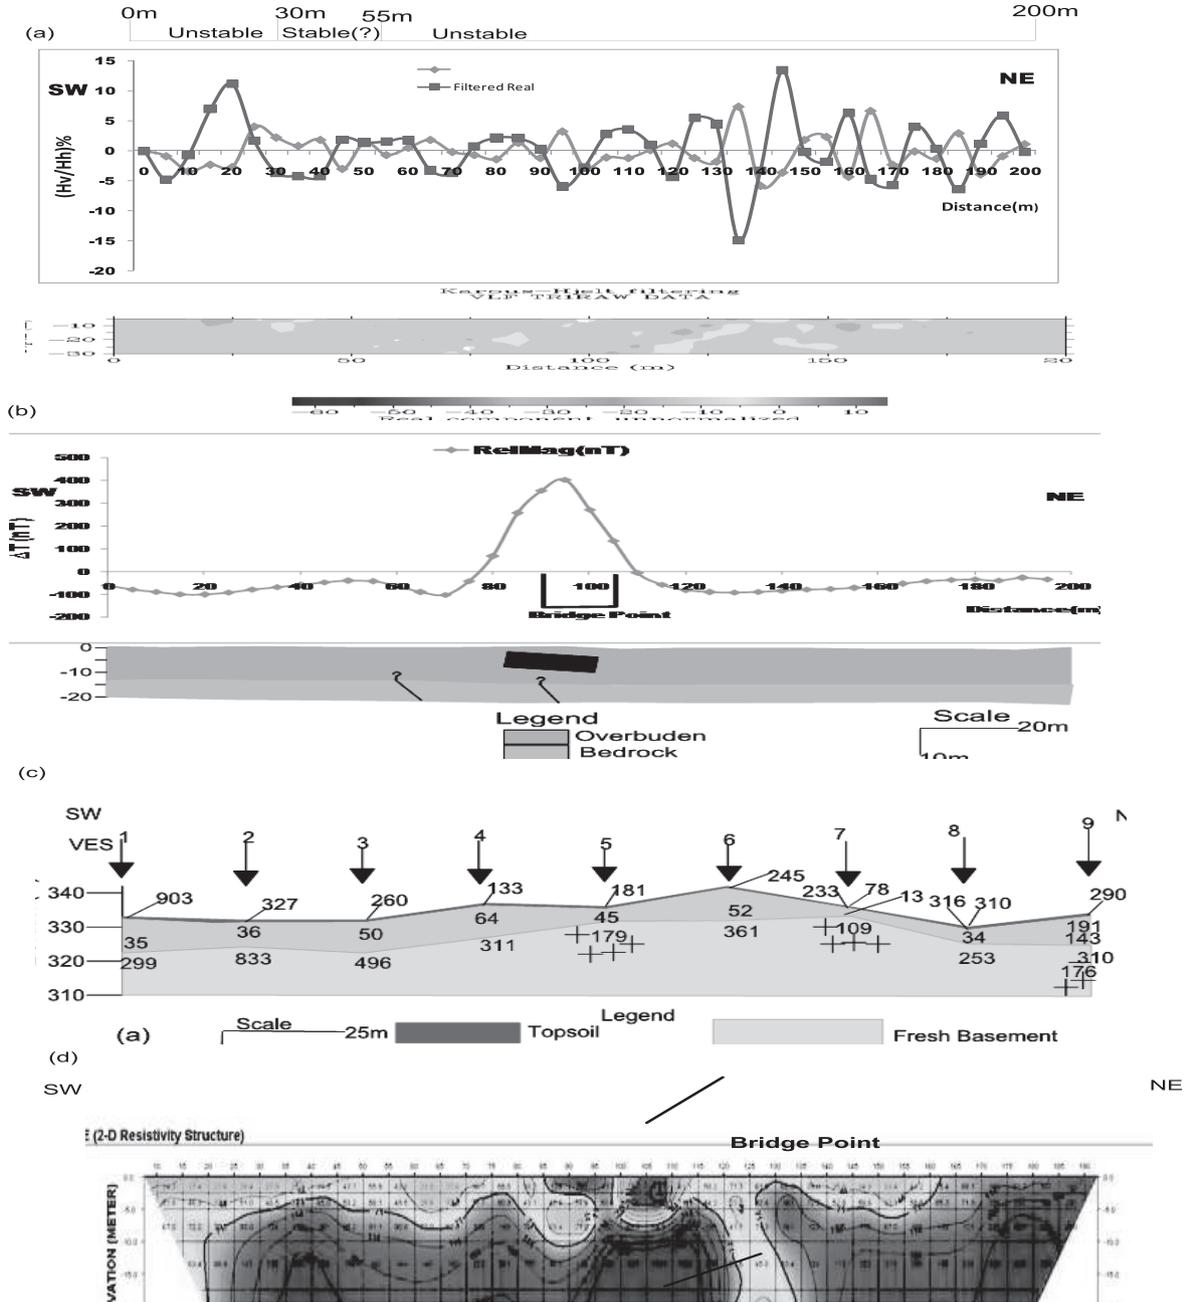
Fig. 6. (a) VLF-EM profile & corresponding section, (b) Magnetic profile & corresponding section, (c) Geoelectric section, and (d) 2-D resistivity structure along traverse 1 at locality 1

A linear conductive body is observed on the VLF-EM section within the unstable portion at distance between 125 m and 135 m (Figure 6a). This is also identified as a magnetic low on the magnetic profile at stations between 115 m and 145 m (Figure 6b). The subsoil in the upper 0 – 5 m within the unstable and classified stable portions on the geoelectric section is inferred to be predominantly clayey

with resistivity values generally less than  $150 \Omega\text{m}$  (Figure 6c). This correlates with the low resistive part in the upper 0 – 5 m on the corresponding 2-D resistivity image with resistivity values that range from  $20 \Omega\text{m} - 60 \Omega\text{m}$  (Figure 6d). Both the geoelectric and 2-D resistivity sections display a bedrock interface that is undulating. This coincides with a major linear feature identified on the corresponding 2-D resistivity structure at distances between 120 m and 135 m (Figure 6d). This suspected linear feature has significant depth extent of about 21 m and may indicate geological features such as a fractured or faulted zones.

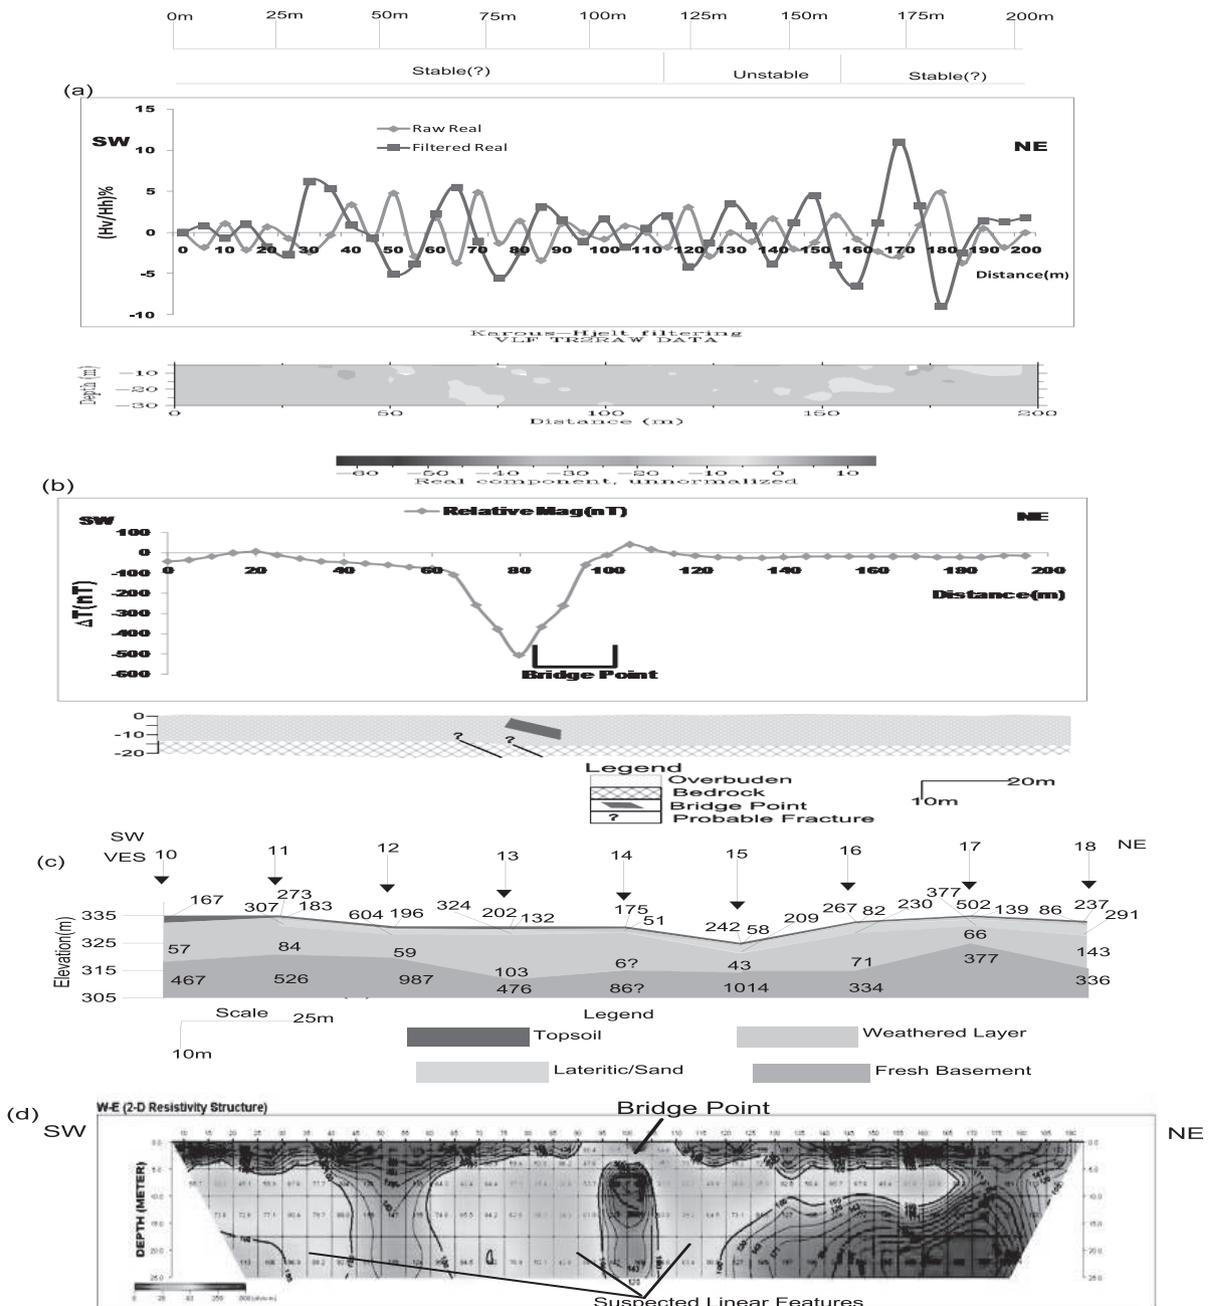
Fig. 7. (a) VLF-EM profile & corresponding section, (b) Magnetic profile & corresponding section, (c) Geoelectric section, and (d) 2-D Resistivity structure along traverse 2 at locality 1

Observed linear features display fairly high conductivity and magnetic low on the corresponding VLF-EM section and magnetic profile respectively (Figures 7a and 7b). These

suspected linear features have significant depth extent of about 20 m and may indicate geological features such as fracture/fault zones and cavities or voids.

The subsoil (both the topsoil and weathered layer) in the upper 0 – 6 m within the classified stable segment and unstable segment with resistivity values that generally less than 200  $\Omega m$  is inferred to compose of clay, sandy clay clayey sand and lateritic sand (Figure 7c). The observed

bedrock interface is uneven and forms a depression at VES stations between 11 and 17. Also, suspected linear features are observed on the 2D resistivity image at distances between 25 – 40 m, 60 – 95 m and 115 -125 m within the classified stable and unstable segments (Figure 7d).

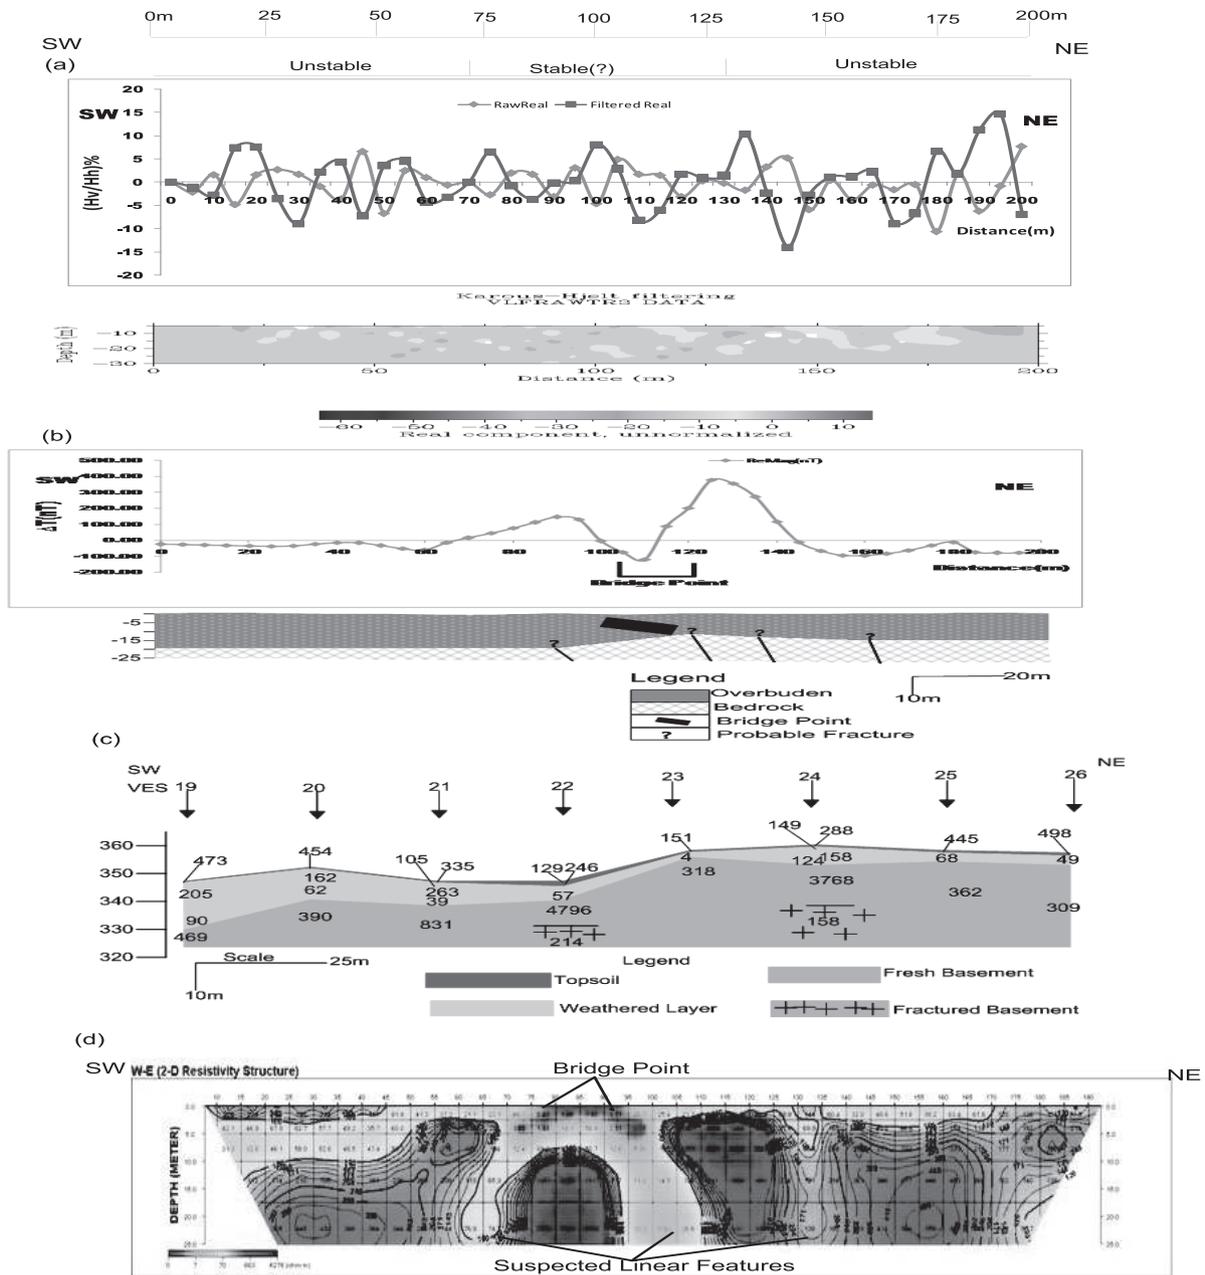
**Fig. 8.** a) VLF-EM profile & corresponding section, (b) Magnetic profile & corresponding section, (c) Goelectric section, and (d) 2-D Resistivity structure along traverse 3 at locality 2

Conductive bodies cross cutting between stations 65 m and 80 m and also between stations 90 m and 110 m were observed on the VLF-EM section (Figure 8a), and the magnetic low between station 60 m and 70 m on the corresponding magnetic profile (Figure 8b). Both the topsoil and weathered layer are observed to compose of clayey materials and sandy clay with resistivity values that are generally less than 150 Ωm (Figure 8c). The bedrock forms a depression between VES stations 20 and 23, and dips towards the southwest direction (Figure

8c). A low resistive part in the upper 2.5 – 10 m is inferred to be clayey on the 2D resistivity image at distance between 10 m and 50 m within the unstable portion (Figure 8d).

This correlates with the weatherd layer observed on the geoelectric section at distance between 0 m and 50 m. Also, a major suspected linear feature observed on the 2D resistivity image at distance between 60 m and 70 m within the stable portion (Figure 8d). The linear feature observed on the 2D resistivity structure within the unstable segment at distance between 95 m and 105 m correlates with the observations on the VLF-EM section.

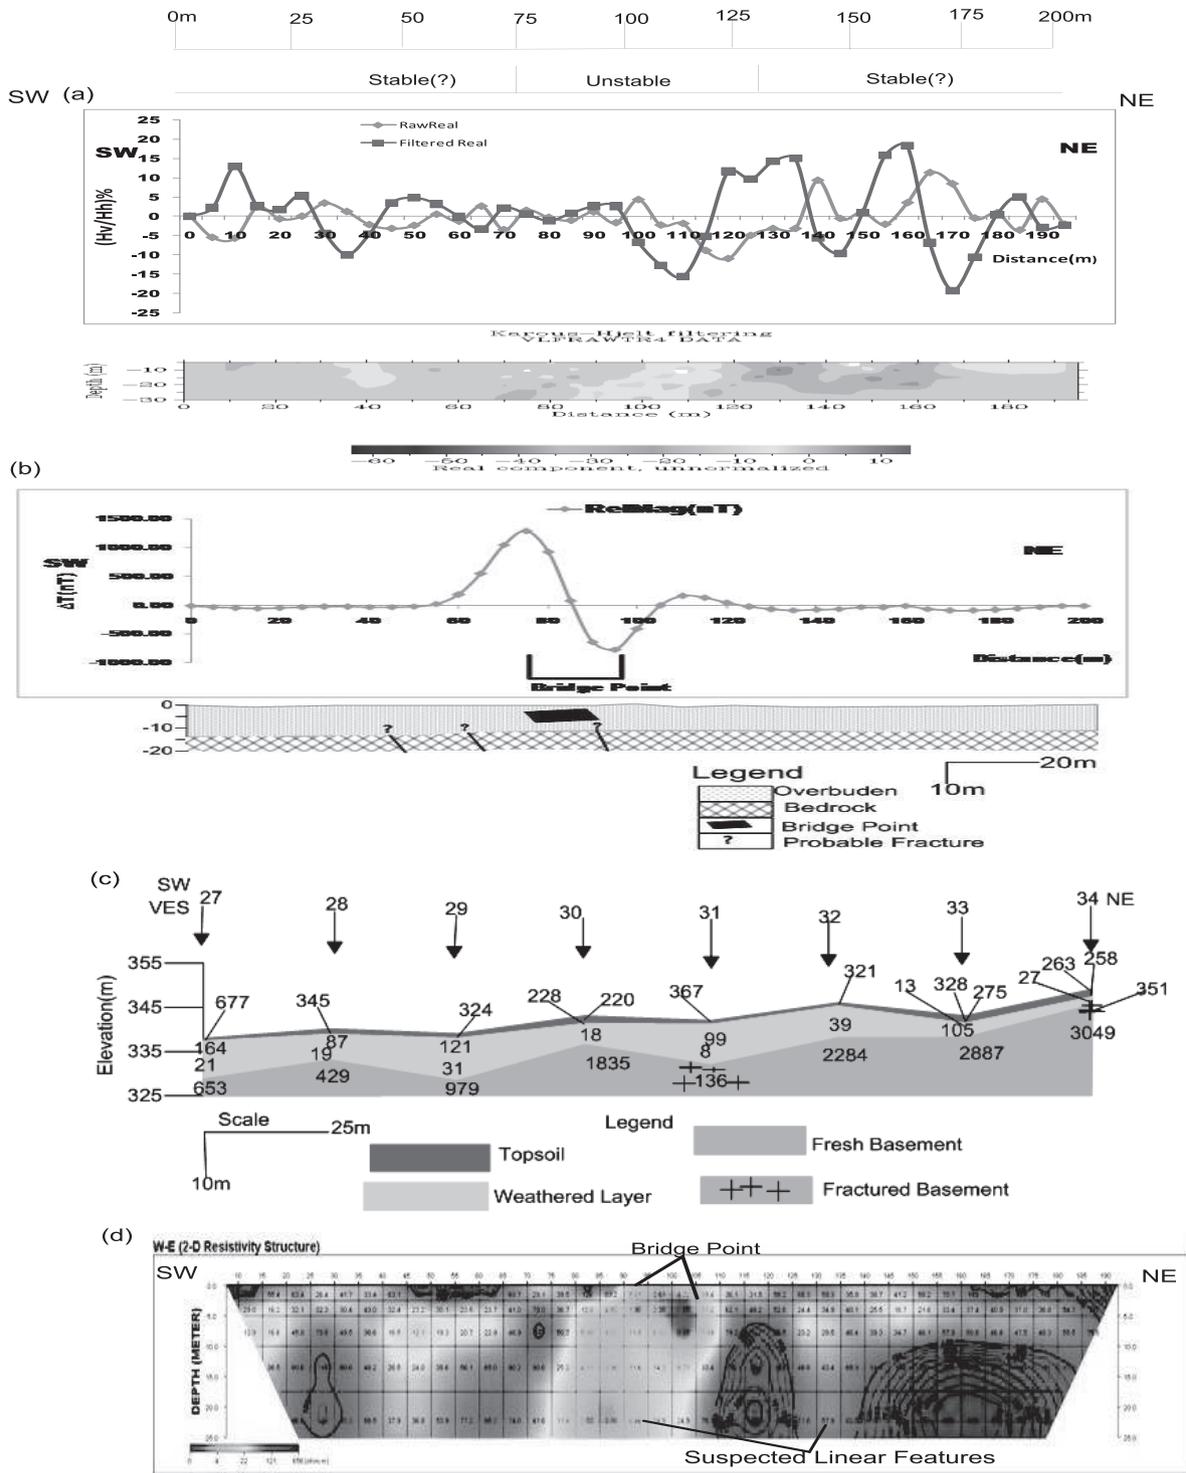
Fig. 9. a) VLF-EM profile & corresponding section, (b) Magnetic profile & corresponding section, (C) Goelectric section, and (d) 2-D Resistivity structure along traverse 4 at locality 2.

The linear conductive body identified on the VLF-EM section at distances between 33 and 44 m (Figure 9a) coincides with the depression observed on the geoelectric section at distance between 35 m and 55 m, and low resistive part observed on the 2D resistivity structure at distance between 40 m and 50 m. Varying magnetic intensity typical of fractures or faults were observed at distance between 60 and 100 m (Figure 9b). The formation in the upper 0 – 6 m on the geoelectric section within the unstable and classified stable segments is characterised by lateritic sand, sandy clay, clay and clayey sand with resistivity values that range from 8 Ωm - 677Ωm (Figure 9c). The overburden thickness ranged from 4.8 – 10.7 m. The bedrock

interface is uneven and forms depressions at distances between 25 – 75 m, 78 – 125 m and between 130 – 175 m. The formation identified as sandy clay and clayey soil in the upper 0 – 4 m on the geoelectric section (Figure 9c) correlates with low resistive part in the upper 0 - 5 m on the corresponding 2-D resistivity image with resistivity values ranging from 12 – 60 Ωm (Figure 9d). A suspected linear feature identified on the 2D resistivity section within the classified stable portion at distance between 120 m and 140 m (Figure 9d) coincides with the highly conductive body observed on the VLF-EM section at distance between 120 m and 165 m . Figures 10(a-d), 11 (a-c) show similar patterns as observed in locality 1 and locality 2.

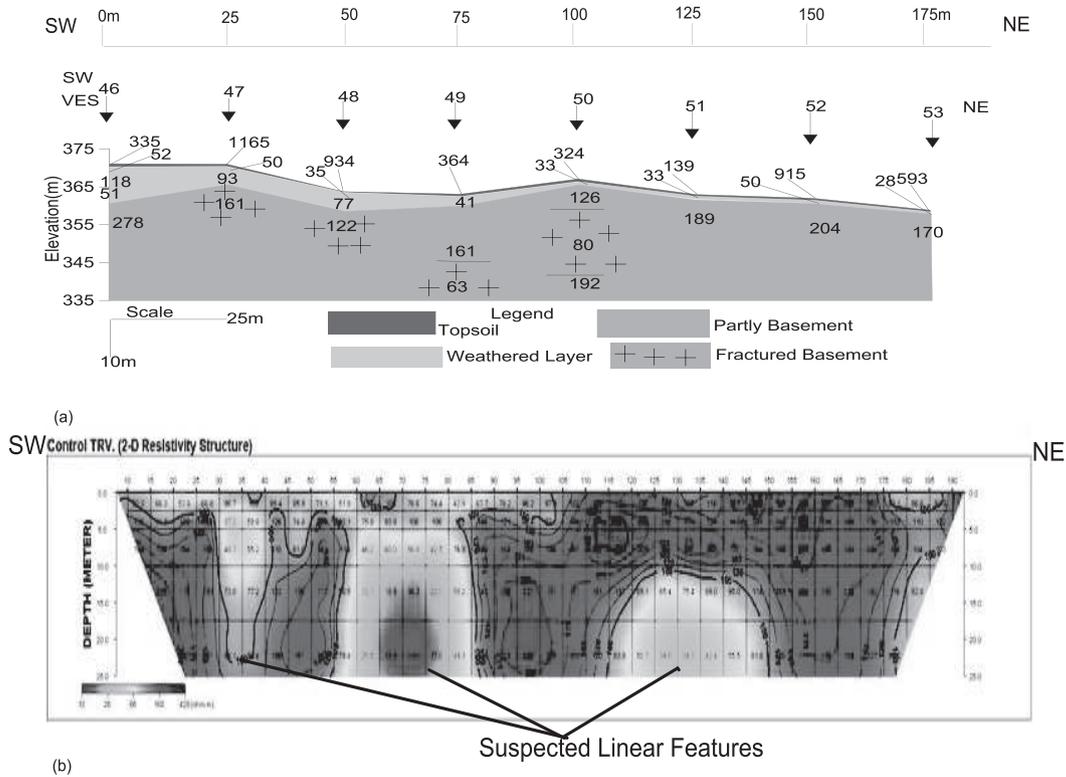
**Fig. 12.** (a) Geoelectric section and (b) 2-D Resistivity structure along traverse 7 (control traverse) at control locality 4

The observed topsoil composed of sandy clay, clayey sand

and lateritic sand with resistivity values that vary from 139  $\Omega$ m to 1165  $\Omega$ m and thickness that varies from 0.4 – 0.6 m (Figure 12a).

These observed geological structures have significant width and depth extent and may indicate fractures and fault zones. Though, the road pavement along this traverse is presumed to be stable, however the observation of major fractures/fault zones are very inimical to the integrity of the road pavement foundation at this locality.
