Integrated geoelectric and hydrochemical assessment of Ilokun dumpsite, Ado Ekiti, in southwestern Nigeria

Olayiwola G. Olaseeni¹, Oluseun A. Sanuade^{1,*}, Solomon S. Adebayo¹, Michael I. Oladapo²

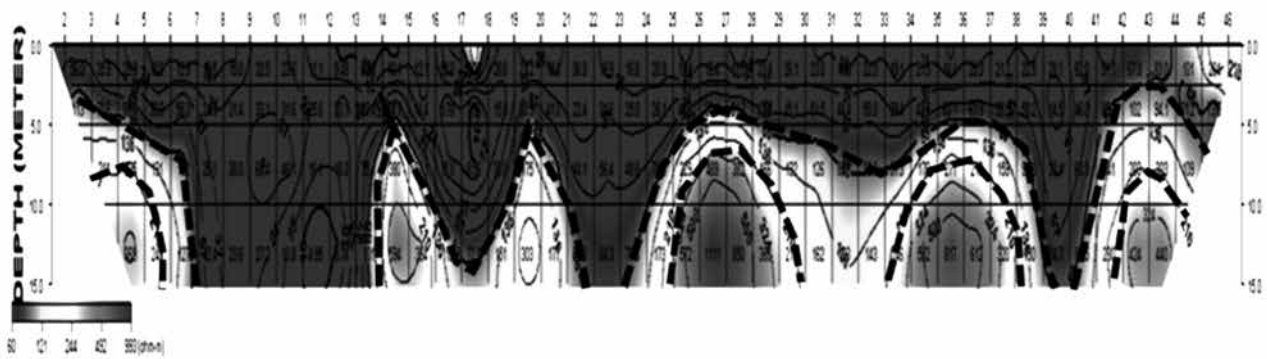
Fig. 5. 2-D resistivity structure within the dump periphery along traverse 1

The resistivity structures obtained along traverse 1 within the dump periphery show that the topsoil has virtually merged with the weathered layer. This is shown by the overlapping

low resistivity values and a relatively small thickness of the layer. (Fig. 5).

Very low resistivity (<8 to <50 Ωm) zones occurred between stations 2 – 44 (10 – 220 m) particularly between stations 4-14 (20 – 70 m), 15 – 19 (75 -85 m) and 38 – 44 (190 – 220 m) along the traverse. The inverted resistivity section shows that the top soil consists of conductive materials from the beginning of the traverse (station 10 to station 44). Less resistive materials are found towards the end of the traverse line. In addition, the resistive materials (>102 Ωm) were disorderly distributed towards the end of traverse within conductive material (<60 Ωm), suggesting a disturbed section. By comparing the exceptionally low resistivity value of the topsoil (9.78 Ωm) with the lowest resistivity value (149 Ωm) obtained from the control traverse, it was observed that there is a decrease in resistivity by 60%. This could imply the presence of pollutants in this zone. It further shows that the impacted area is migrating from this layer towards the deeper layer.

The underlying layer (weathered layer) has electrical resistivity value between 42 and <244 Ωm with a thickness of <5.0 to >15 m. The lowest resistivity value in this unit is

42 Ωm and shows a decrease of 19% in comparison with the reference resistivity value in the control traverse. The reduction in the resistivity values might indicate that the weathered layer within the section has been polluted by the leachate.

The 2-D resistivity structure along this traverse also shows a series of basement ridge/suppressions between stations 2 – 6 (10 – 30 m), 14 – 21 (70 - 105 m), 29 – 33 (145 – 165 m) and 38 – 42 (190 – 210 m). A major discontinuity between stations 7-14 (35-70 m) along traverse 1 may be fractured/fault zones. The Ilokun dumpsite is located directly above the structural features delineated (fractures/fault) along traverse 1. These structural features can serve as a conduit, thus allowing leachate produced within the dump periphery to migrate into the groundwater (Adebayo *et al.*, 2015). The bedrock material beneath this unit tends to be evenly distributed with an increased resistivity value (432 - 993 Ωm).

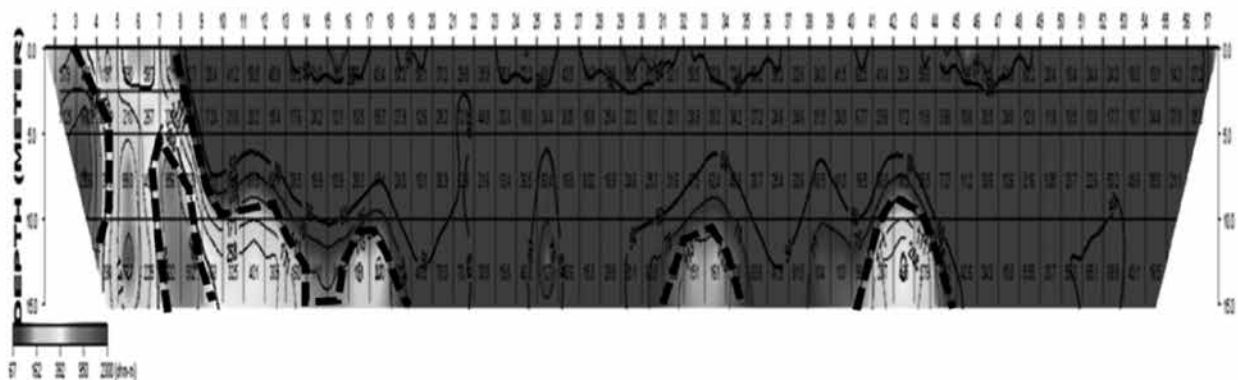
Fig. 6. 2-D resistivity structure along traverse 2.

The resistivity structures obtained along traverse 2 within the dump periphery show that the topsoil has virtually merged with the weathered layer. This is evident by the overlapping low resistivity values and a relatively small thickness of the layer (Fig. 6). There is also an irregular order of resistivity values (67 to 2300 Ωm). Pockets of resistive material (392 -

>950 Ωm) were enclosed between station 2 to station 8 (10 - 40 m) within materials of low resistivity (<67 Ωm). This is indicative of the starting point of the dump periphery and could imply that the unit has been disturbed.

Low resistivity (<67 Ωm) zones between stations 8 – 57 (40 - 285 m) were also delineated as this signifies that the low resistivity topsoil within the identified zones may have been polluted by leachate from the dumpsite. A decrease of 55% was recorded when the lowest resistivity value (149 Ωm) was compared with the reference unit for the topsoil. This may indicate that this zone has been polluted by leachate from the dumpsite (Pedro *et al.*, 2010; Sudha *et al.*, 2010).

The second layer is the weathered layer having resistivity values of less than 150 Ωm along traverse 2. This layer was characterized by patches with very low resistivity (<67 Ωm) beneath the traverse 2. The resistivity structures show the thickness of the weathered layer that ranges from <1.0 to >15 m. The third layer is the fresh basement bedrock. It exhibits a moderately high resistivity of about 2306 Ωm . Depth to the basement rock varies from about <2.0 - >15 m.

Generally, traverses 1 and 2 show a percentage reduction in resistivity value, ranging from 19% to 60%. This suggests that the pollutants have infiltrated both the topsoil and weathered layer, leading to an increase in conductivity of this section. However, VES was conducted in order

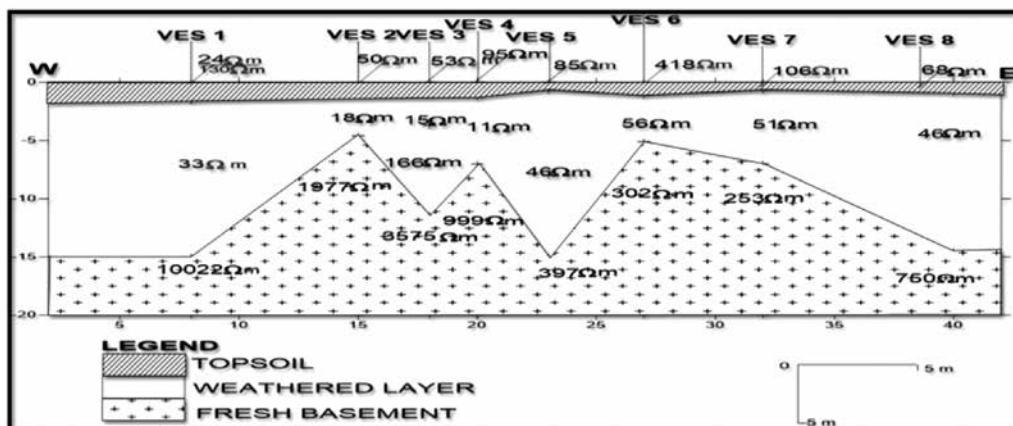
Fig. 9. Lithological characterization of the subsurface along traverse 1

From the interpreted VES curves (Figure 9), the topsoil has

resistivity values ranging from 24 to 418 Ωm and an average resistivity of 112 Ωm with an average thickness of 1.2 m. The weathered basement shows a resistivity value between 7 and 246 Ωm with an average resistivity of 37 Ωm . Its thickness ranges from 2.4 m to 15 m. Comparing the resistivity value from the control traverse (69 Ωm) with that obtained in this layer, there is a reduction in resistivity value between 8 m (at VES 1) to 200 m (at VES 8) along the traverse. This suggests that this unit was infiltrated by pollutants. The resistivity of the bedrock ranges from 253 to 10021 Ωm . The basement rock is fresh between station 15 (at VES 2) to station 20 (at VES 4), and it is fractured between station 8 (at VES 1) and station 23 (at VES 5). The fractured basement could serve as a conduit for transporting the pollutants into the groundwater system (Ayolabi *et al.*, 2014; Ganiyu *et al.*, 2016).

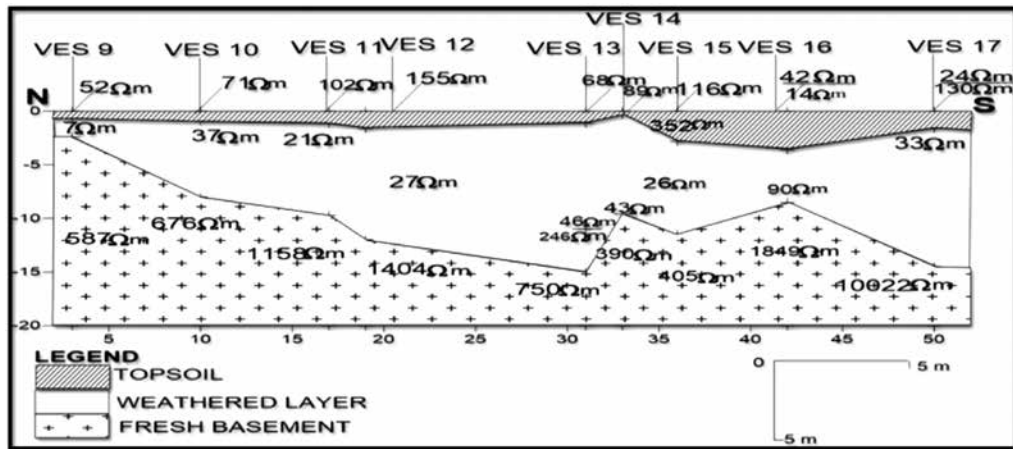
Fig. 10. Lithological characterization of the subsurface along traverse 2

Along traverse 2 (Fig. 10), the VES-derived geoelectric

section depicts a three-layer sequence. The resistivity of the topsoil is between 14 and 130 Ωm , and the resistivity value increases away from the central portion of traverse. The average resistivity is 80 Ωm and its average thickness is 1.0 m

The average thickness of the weathered layer is 12 m. The resistivity ranges from 7 to 246 Ωm and 59 Ωm is the average resistivity value. To ascertain whether or not this layer has been polluted, a comparison was made with the value obtained from the control layer (69 Ωm).

Juxtaposing the lowest resistivity value (7 Ωm) with that of the reference lithology (69 Ωm), a decrease in resistivity is apparent. This difference may be caused by pollutants migration. The basement underlies the conductive section, and its resistivity value ranges from 390 to 10022 Ωm , and it is fractured at station 50 (at VES 17). As stated, this could serve as a conduit for pollutants into the groundwater system. The real formations of the weathered layer have been highly distorted through the infiltration of contaminants.

It is observed that the leachate from waste materials have polluted the groundwater in the dump periphery. This is evident from the geoelectric sections of two traverses (Figs. 9-10) established within the dump periphery compared to the columnal section (Fig. 8) of the control point.
