Integrated geoelectric and hydrochemical assessment of Ilokun dumpsite, Ado Ekiti, in southwestern Nigeria

Olayiwola G. Olaseeni¹, Oluseun A. Sanuade^{1,*}, Solomon S. Adebayo¹, Michael I. Oladapo²

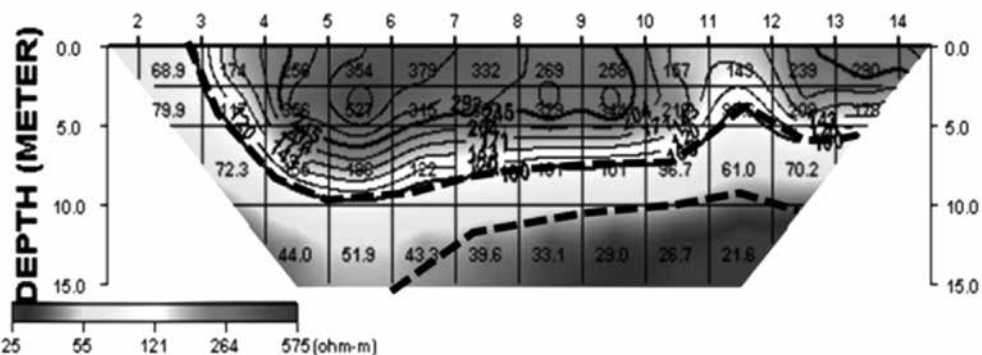
Fig. 4. 2-D resistivity structure along the control traverse.

a lateritic layer (Loke, 2000). The lowest resistivity value (149 Ωm) was chosen as a reference resistivity to compare with other resistivity values in the topsoil of traverses acquired within the dumpsite (Pedro *et al.*, 2010; Sudha *et al.*, 2010). This lateritic layer extends from about 15 m of the profile to the end of profile. However, there is a different layer, which is probably a sand formation between 55 and 60 m. Furthermore, the underlying layer (weathered layer) exhibits resistivity of a fresh water-bearing zone with a value of 51.9 to 79.9 Ωm (Loke, 2000). This occurred between the depth of 5 and 12 m along the traverse, suggesting that the section had not yet become polluted with contaminants. Low resistivity values (52–79.9 Ωm) were noticed from 10 to 70 m sequentially along the profile. The lowest resistivity value (51.9 Ωm) was taken as the reference resistivity (background value) to be compared with those obtained from the dumpsite (Pedro *et al.*, 2010; Sudha *et al.*, 2010).

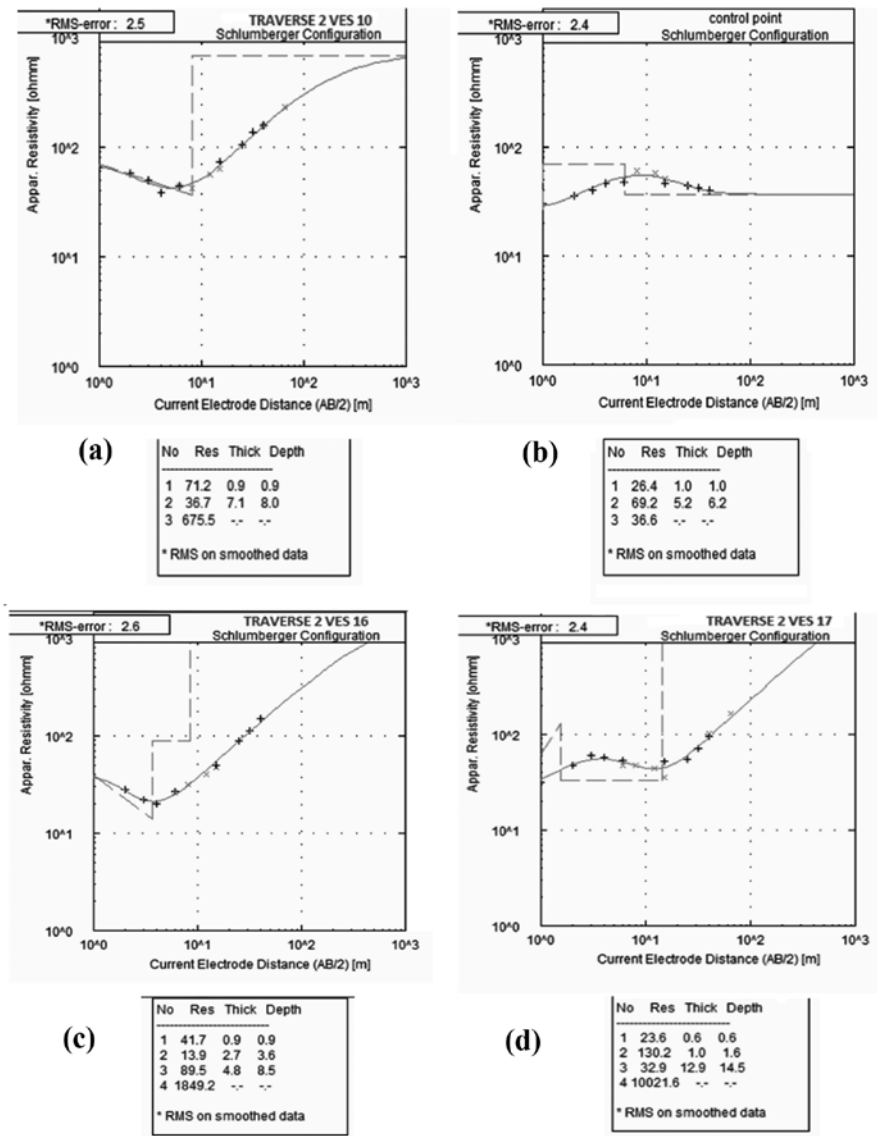
Fig. 7. VES curve types: (a) H-curve type, (b) K-curve type, (c) HA-curve type, and (d) KH-curve

The curve type varies from 3-layer H-type (50%), K-type (6%) to 4-layer HA (22%) and KH (22%). Selected sounding curves and their computer generated models are presented in Figure 7.

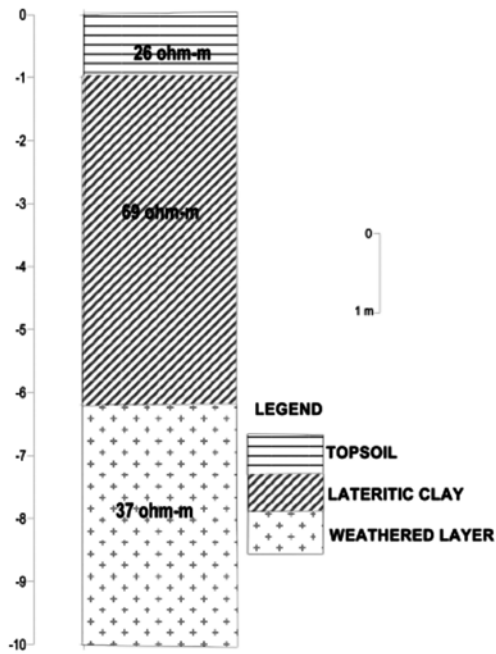
Fig. 8. Lithological characterization of the subsurface along the control point

The VES-derived columnal section at the control point (Fig. 8) shows a three-layer sequence: top soil, clayey unit, and the fractured basement that serves as the control layer.

The resistivity of upper topsoil layer is 26 Ωm with a thickness of 1.0 m. The only resistivity value observed for topsoil in this unaffected section is 26 Ωm . It was selected as a comparison for other resistivity values obtained from the affected sections. The conductive weathered layer below the topsoil generally exhibits a fresh water resistivity of 69 Ωm (Loke, 2000). Its thickness reaches up to 6.2 m, which was used as a means of comparison with resistivity values obtained from the affected sections. This layer is characterized by a high water retention capacity that has low permeability. Beneath the clayey section is the fractured basement rock with a resistivity value of 37 Ωm .
